SMITHSONIAN INSTITUTION
BUREAU OF AMERICAN ETHNOLOGY
BULLETIN 121

ARCHEOLOGICAL REMAINS IN THE
WHITEWATER DISTRICT
EASTERN ARIZONA

PART I. HOUSE TYPES

By FRANK H. H. ROBERTS, JR.

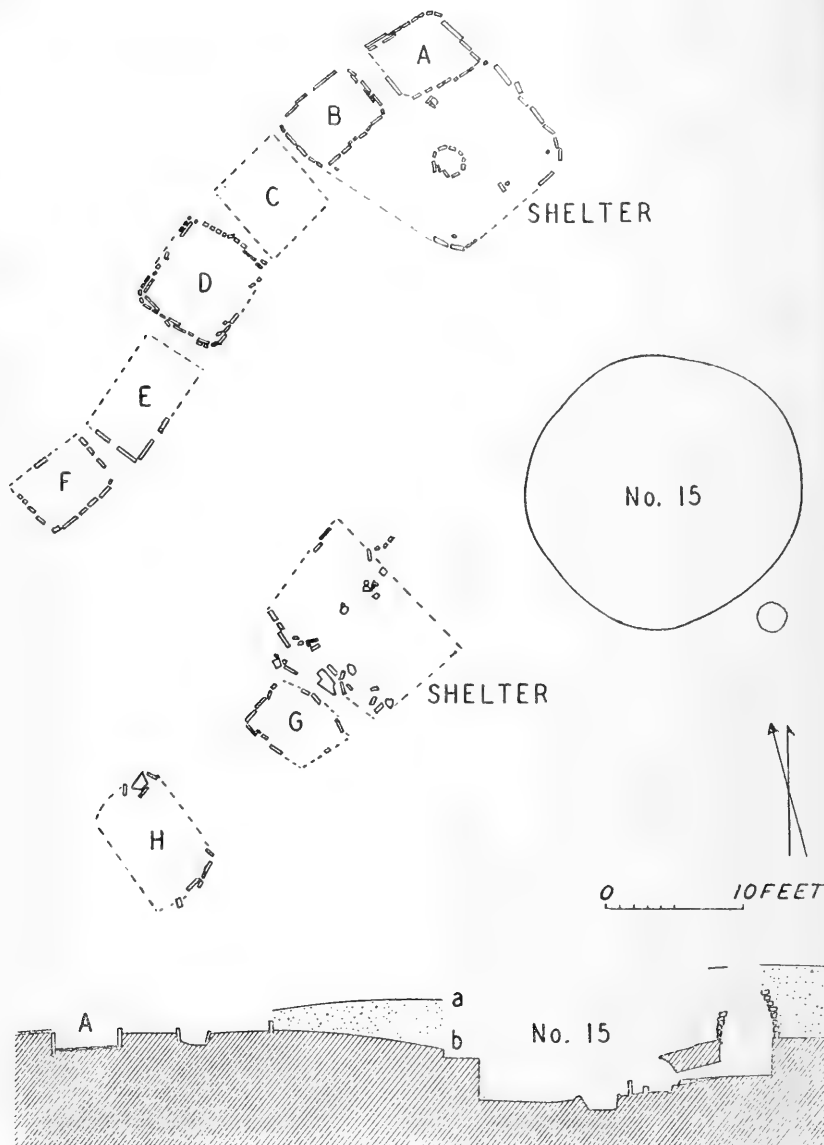
FIGURE 37.—Plan of No. 15 group of house, granaries, and shelters.

The group of granaries associated with structure No. 15 constituted one of the more significant features at the site. They were located 19 to 25 feet (5.791 m to 7.620 m) north and west from the dwelling and were built in an orderly row (fig. 37). The pit portions were rectangular and there was evidence to show that they had been covered with pole, brush, and plaster superstructures of the

for use elsewhere. The outlines of the pit were not sharp and clear as the earth walls had slumped in places and traces of the stones that might have been there were lost. This structure (fig. 37, *C*) was filled with corn when it burned and several inches of charred grain and cobs covered the floor. Granary *E* also burned and some of the stones were missing from its pit. There were signs on the walls, though, to show that stones were used there. In several of the examples a number of courses of horizontally laid stones were used to augment the height of the slabs and approximately half of one wall in another (fig. 37, *B*) consisted of this type of masonry. The floors of a number of the pits (*A*, *D*, and *G*) were completely paved with slabs, while in others scattered flagstones were embedded in the plaster. Two of the structures showed that small fires had been kindled on the floor near the center of the pit, although there was no actual fire basin present. This is an indication that on occasions, when they were not fulfilling their functions as storage places, the granaries were used as temporary habitations.

Two surface shelters were associated with the granaries. One of these was erected in front of the two at the north end of the row (fig. 37, *A*, *B*; pl. 20, *a*). An area on the surface was enclosed by a series of stone slabs set upright in the ground (fig. 38). In the center of this space was a stone-lined fire pit. Six upright posts, two placed midway along the front and back sides and four near the corners, had supported a rude arbor, probably a brush roof similar to those previously described. Except for the sides of the granaries, which would have served in that capacity at the back of the enclosure, there was nothing to indicate the former existence of any kind of walls. The rude structure thus formed would shelter the people from the sun and give some protection during light showers, but it would not have been very serviceable in times of severe storms. The remains of a similar shelter were present at the south end of the group. The latter was not as well preserved, although there were indications that the floor had been enclosed by slabs and that six posts were used to support the covering. The fire pit associated with this second structure was not in the enclosed space but just outside, between it and the dwelling. The important factor about this group of granaries is the manner in which they foreshadow the row of contiguous rooms and associated ceremonial chamber in the unit-type house of subsequent years. When the general plan and grouping of the No. 15 complex is compared with others discussed in following pages this becomes more apparent.

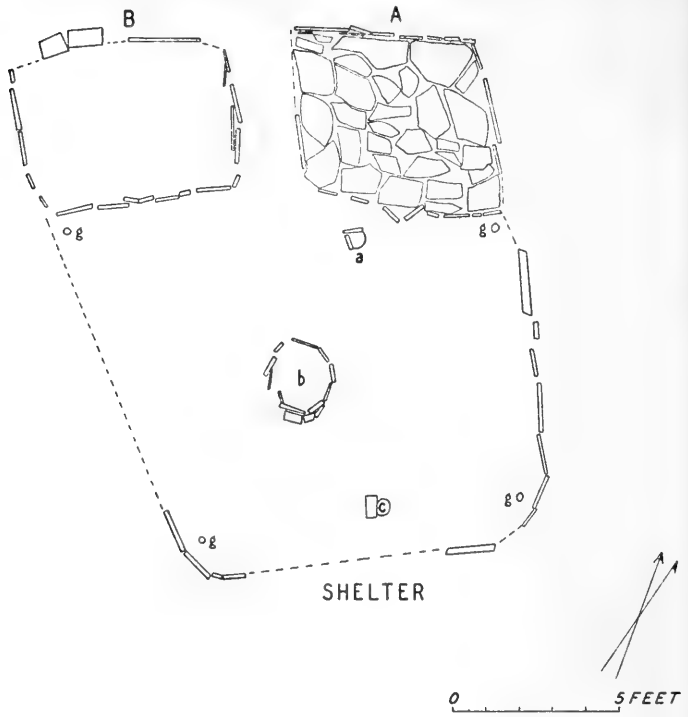
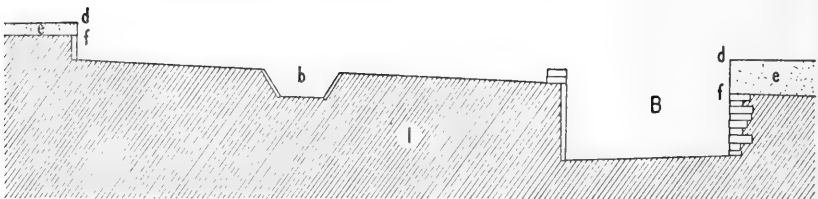
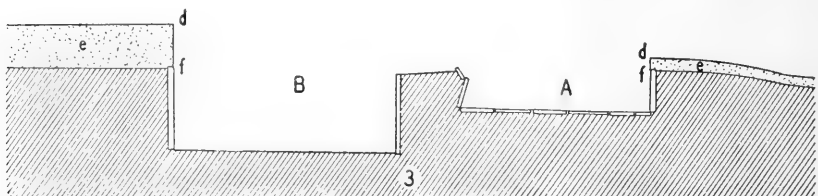
FIGURE 38.—Granaries A and B and shelter in No. 15 group. *a*, hole for support post; *b*, fire pit; *c*, hole for support post; *d*, present surface; *e*, sand fill; *f*, original surface; *g*, holes for corner supports for arbor.

The granary pits varied somewhat in size and depth. *A* was 5 feet 10 inches (1.778 m) long and 5 feet (1.524 m) wide. At its north end it was 2 feet 6 inches (76.2 cm) deep and at the south end 2 feet 5 inches (73.66 cm). The distance between it and *B* was 1

foot 7 inches (48.26 cm). *B* was 6 feet 4 inches (1.930 m) long, 4 feet 9 inches (1.447 m) wide, and 1 foot 3 inches (38.1 cm) deep at both ends. *C* was approximately 6 feet (1.828 m) square, but exact measurements could not be determined. The depth at the ends of the pit was 2 feet 8 inches (81.28 cm). *D* was 7 feet 3 inches (2.209 m) long, 6 feet 4 inches (1.930 m) wide. The depth at the north end was 1 foot (30.48 cm) and at the south end 9 inches (22.86 cm). That was the shallowest pit in the group. *E* was 1 foot 6 inches (45.72 cm) from *D*, had a length of 7 feet 6 inches (2.286 m), a width of 4 feet 6 inches (1.371 m), and a depth of 2 feet (60.96 cm) at both ends. *F* was only 1 foot 3 inches (38.1 cm) from *E*. Its length was 6 feet (1.828 m), its width 4 feet 4 inches (1.320 m), the depth at the north end 2 feet 2 inches (66.04 cm) and at the south 2 feet 8 inches (81.28 cm). *G* was 19 feet (5.791 m) from *F*. The length of *G* was 5 feet 6 inches (1.676 m) and the width 4 feet 6 inches (1.371 m). The depth was 1 foot (30.48 cm) at both ends. *H* was 8 feet (2.438 m) from *G*. The stone had been removed from the sides of the pit but its outline was distinct. It had a length of 8 feet 2 inches (2.489 m) and a width of 5 feet 6 inches (1.676 m). Like *G*, the depth at each end of *H* was 1 foot (30.48 cm).

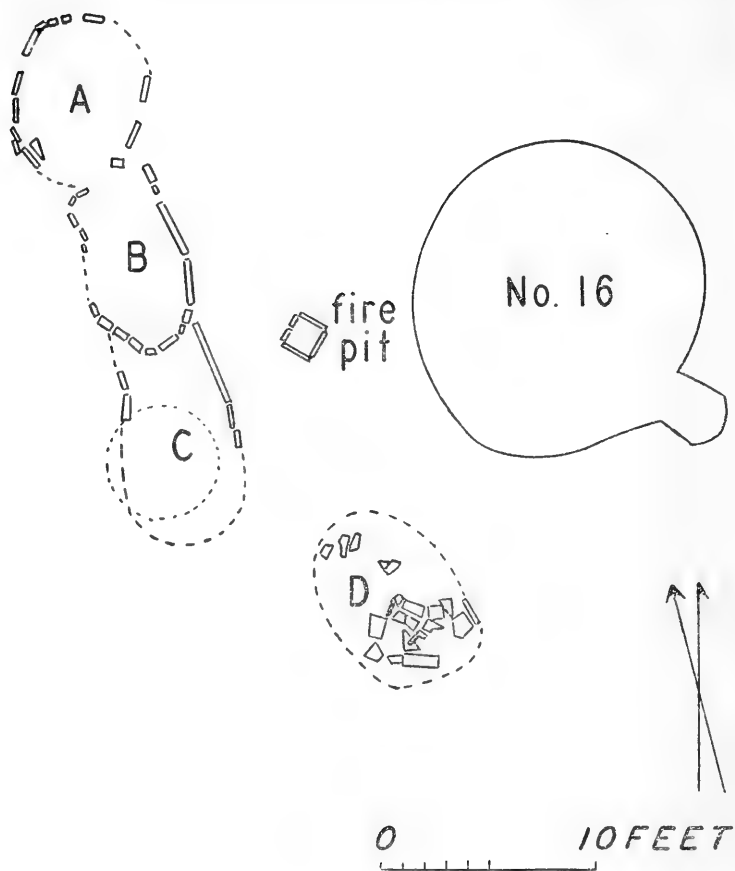
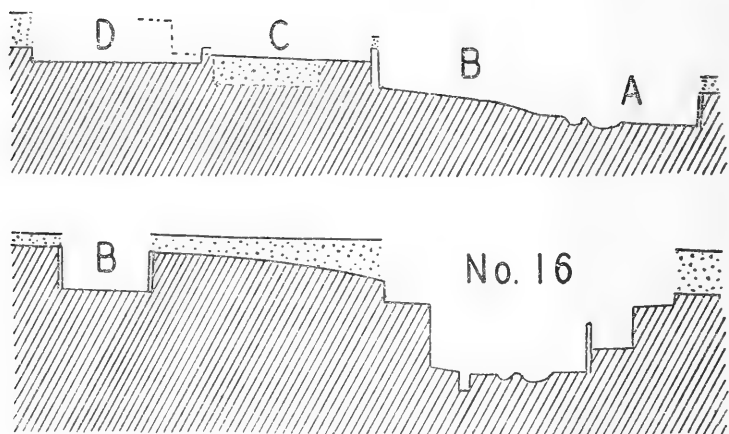
FIGURE 39.—Plan of No. 16 house and granary assemblage.

The group consisting of No. 16 and its adjacent storage structures (fig. 39), represented an earlier stage in the sequence than the No. 15 group. Some of the features noted in the latter were present in the No. 16 assemblage in cruder and less developed form and clearly showed certain steps in the evolution of characteristic elements in the unit-type structure. The granaries were built in a row to the west and south of the house and differed to some extent

The row of granaries was 9 feet 6 inches (2.895 m) west of structure No. 16. Midway between the surface structures and the dwelling was a surface fire pit lined with stone slabs (fig. 39). There were no traces of a shelter or arbor like that in front of the No. 15 granaries, *A* and *B*. The fire was merely built in the open. The granaries differed from those in the group near structure 15 in that they were roughly oval or circular in form. They were of the same

evidence for this was not as clear-cut as could be desired and it is possible that the other form was used. The other two (fig. 39, *A*, *B*) were of the truncated type, described in the discussion of the No. 15 group, as indicated by the timber molds at the edges of the pits.

Two of the granaries (fig. 39, *A*, *B*) were connected by a small doorway. This is unusual but is probably attributable to the fact that they were used, at least temporarily, as a dwelling. One of the pits (*B*) had a metate and mano lying on the floor at the center of the chamber and the other (*A*) had a small fire basin in the floor near the opening between the two pits (fig. 41). This basin was dug into the floor and had simple earth walls. It had sufficient use to burn the soil a deep red. Close to the fire pit and nearer the center of the pit was a depression in the floor that was almost filled with wood ashes. Whether the feature was originally intended for such use or had another purpose before serving as a depository for ashes could not be determined. It seems rather curious that so large a place should be provided for an ash receptacle in so small a structure unless the residue was definitely being retained for some specific purpose. Parts from two large storage jars were also in this room. Pieces from one of them were found on the floor in No. 16, a factor that is good evidence for the contemporaneity of the structure.

Granary *C* (fig. 39) had the same general shape and size as *B*. The floor had been paved with small, thin slabs of stone. The chief matter of interest in connection with the structure was in the fact that it overlay a circular pit containing a triple burial (fig. 25, Nos. 26, 27, 28). A young adult female and two children were interred there before the granary was created. There were no accompanying mortuary offerings to provide a clue to the stage to which they belonged. Only one of the skulls was in a condition to give any indications of its general characteristics and since it was undeformed, that fact suggests that the group was among the earlier settlers at the site. The burials were only 9 inches (22.86 cm) below the floor of the storage bin, but there was clear evidence that the pit for the bin was dug at some time subsequent to the placing of the bodies there.

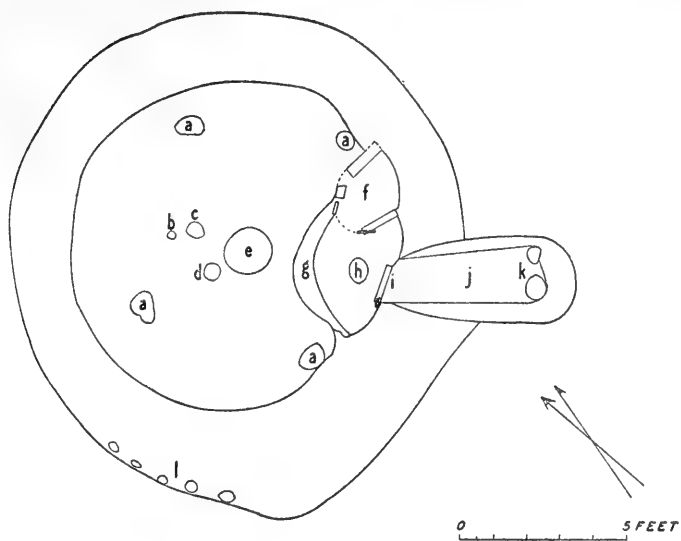
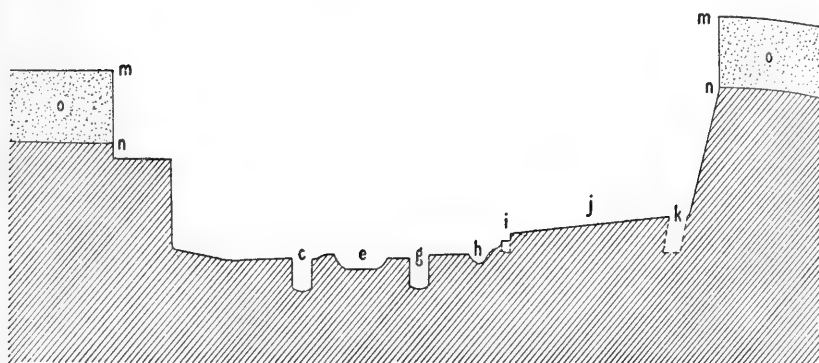
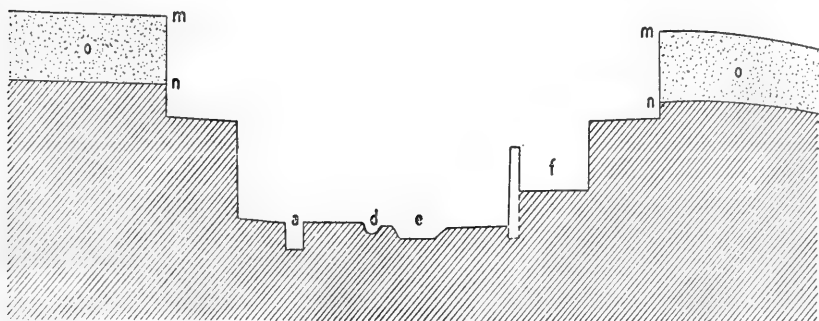
FIGURE 40.—Structure 10. *a*, holes for main roof supports; *b*, small storage hole; *c*, sipapu; *d*, pot rest; *e*, fire pit; *f*, storage bin; *g*, groove for compartment wall; *h*, basin in floor; *i*, sill in passage opening; *j*, passage; *k*, holes for ladder poles; *l*, placements for side poles; *m*, present surface; *n*, old surface; *o*, sand fill.

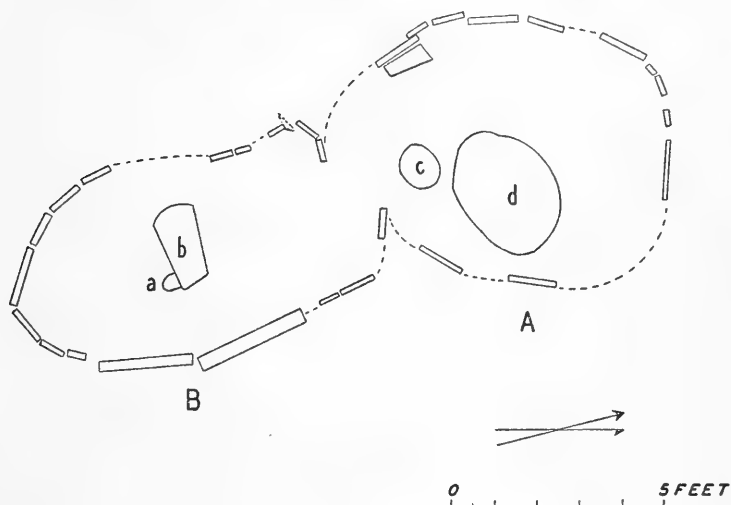
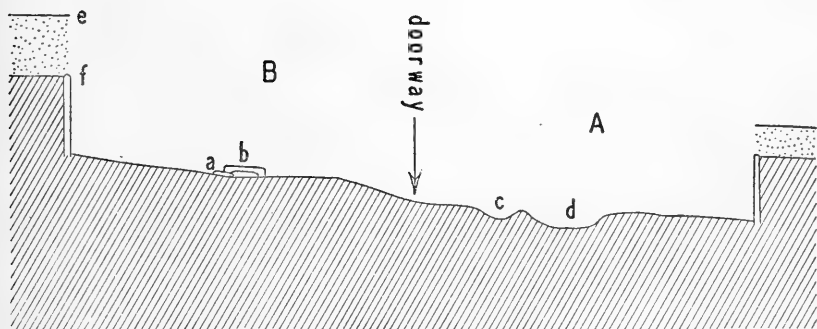
FIGURE 41.—Granaries A and B of the No. 16 group. *a*, mano or hand milling stone; *b*, metate stone; *c*, fire pit; *d*, storage basin; *e*, present surface; *f*, original ground level.

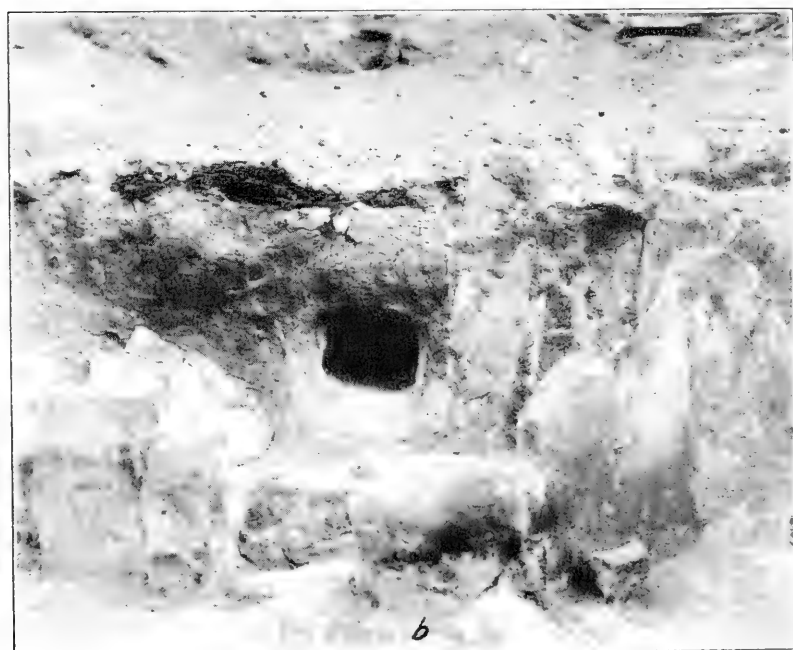
b. Compartment wall and ventilator of structure 15.

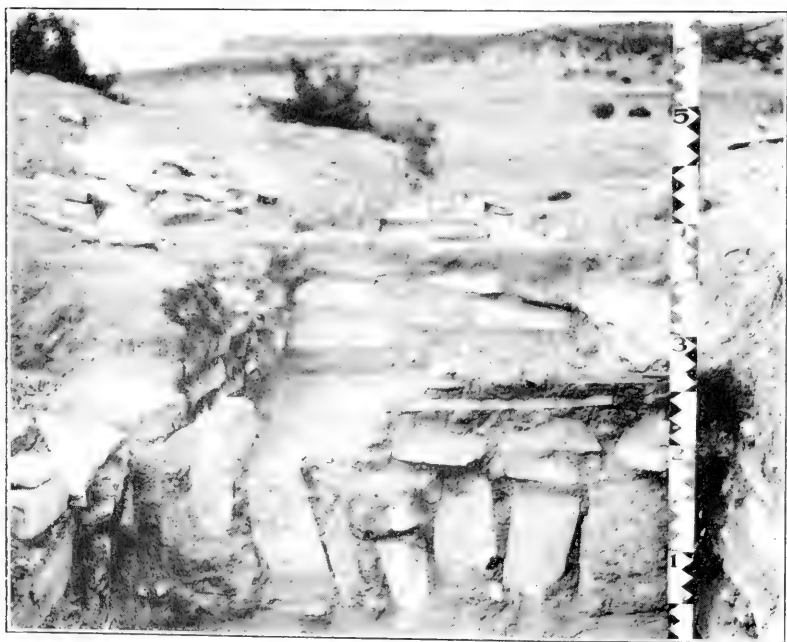
Wall construction in second unit.

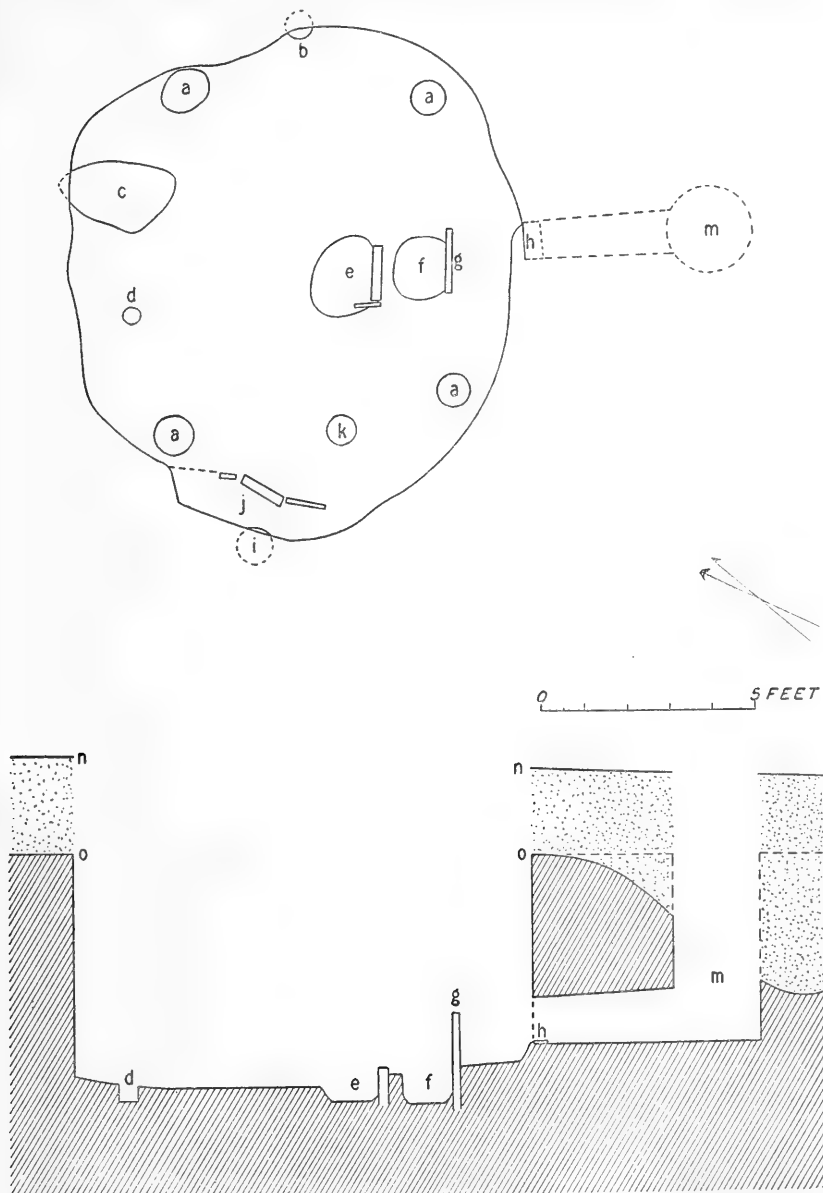
FIGURE 42.—Structure 17. *a*, holes for support posts; *b*, subwall pocket; *c*, storage pit; *d*, sipapu; *e*, fire pit; *f*, basin for ashes and ladder; *g*, deflector; *h*, sill in ventilator opening; *i*, subwall pocket; *j*, storage bin; *k*, pot rest; *m*, ventilator shaft; *n*, present ground level; *o*, original surface.

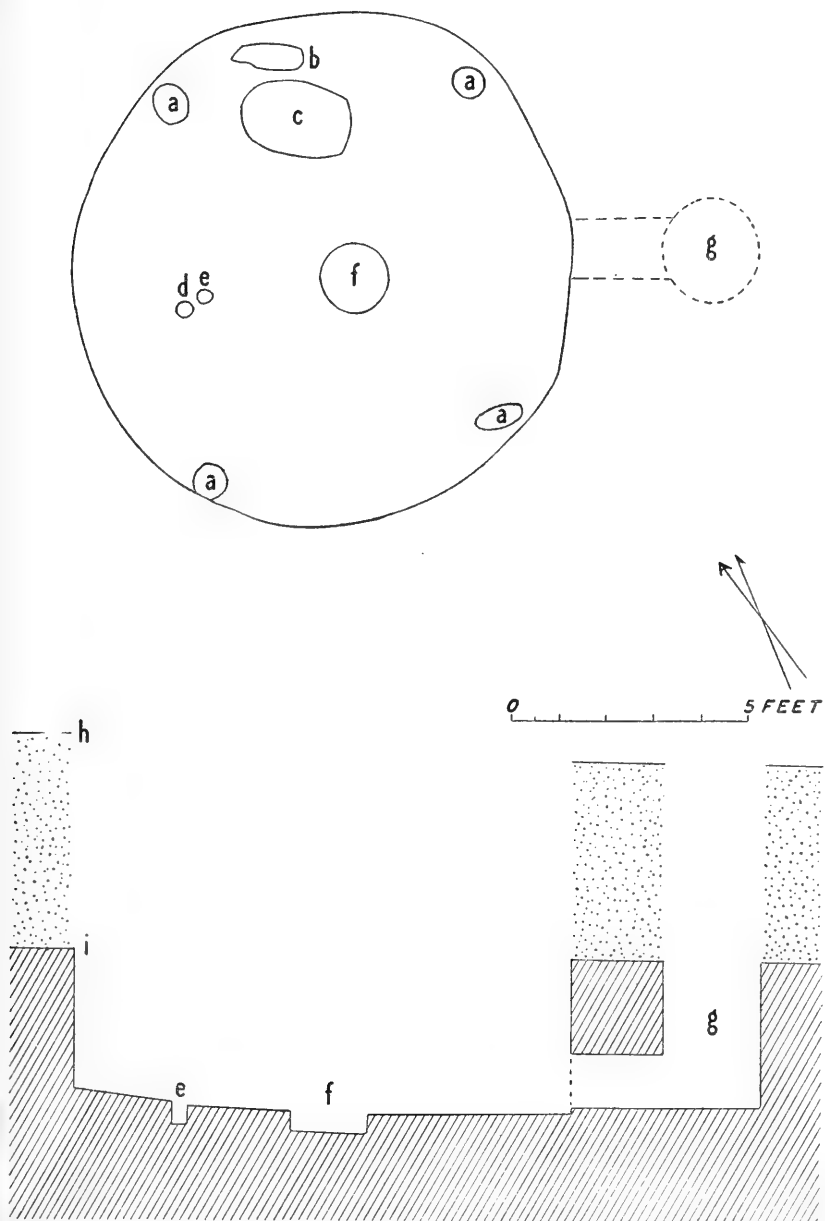
FIGURE 43.—Structure 18. *a*, holes for roof supports; *b*, storage pit in floor; *c*, storage basin; *d* and *e*, sipapus; *f*, fire pit; *g*, ventilator shaft; *h*, present surface; *i*, old ground level.

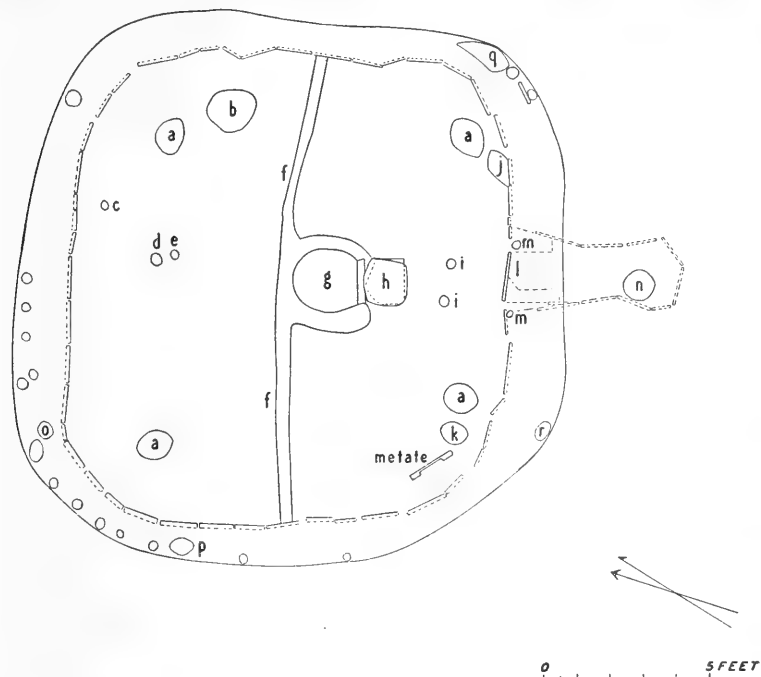
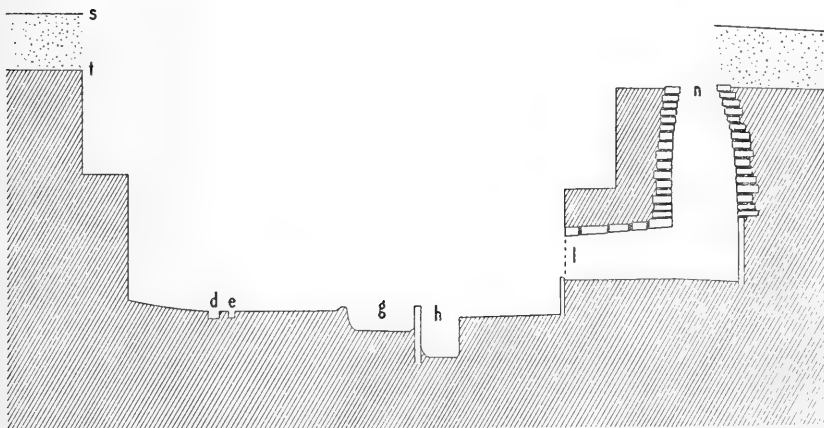
FIGURE 45.—Kiva A. *a*, holes for roof supports; *b*, storage pit; *c*, storage hole; *d* and *e*, sipapus; *f*, plaster ridge on floor; *g*, fire pit; *h*, old ladder pit; *i*, ladder pole depressions; *j*, storage pocket; *k*, pot rest or storage pocket; *l*, ventilator aperture; *m*, poles reinforcing ventilator opening; *n*, ventilator shaft; *o*, slanting timber placements; *p*, *q*, *r*, storage pockets on bench top; *s*, present surface; *t*, old ground level.

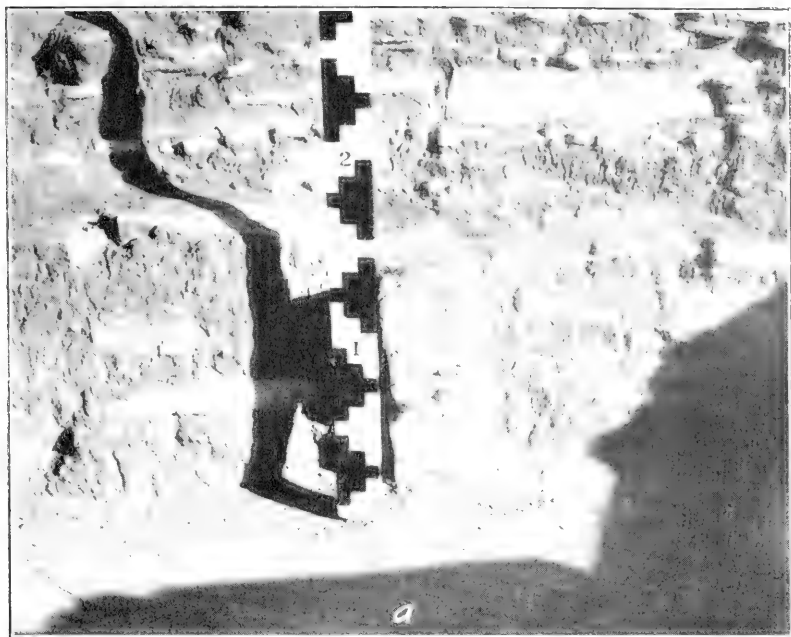
a. Stone step and wall construction in room 8.

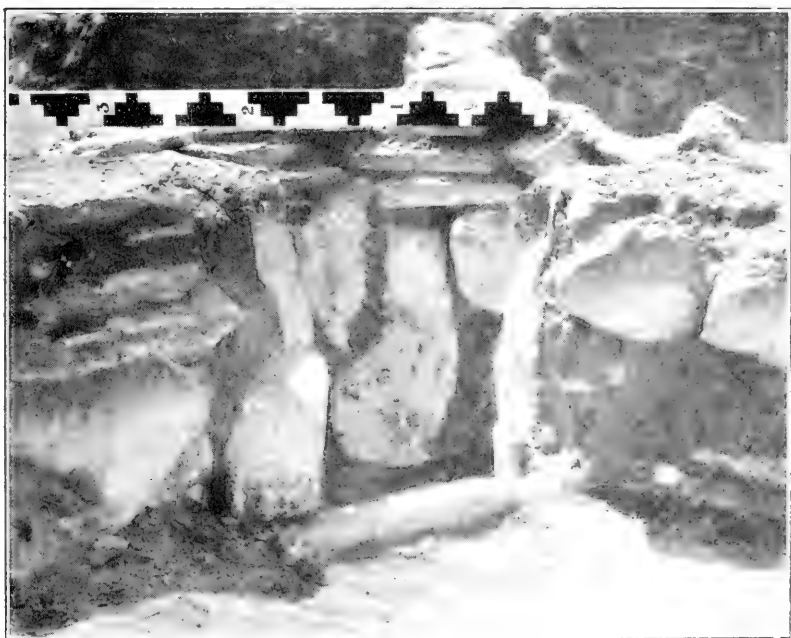
b. Corner bin in room 11.

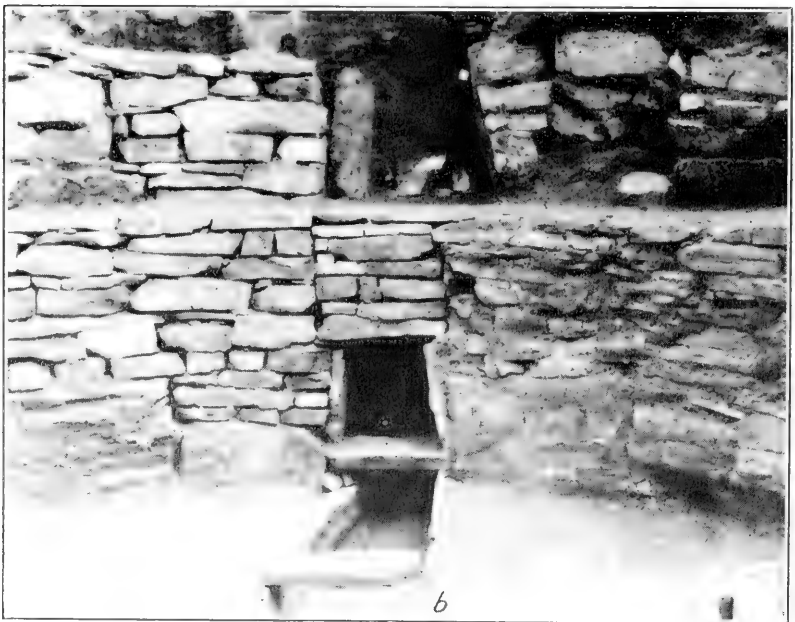
b. Ventilator openings in Kiva B.

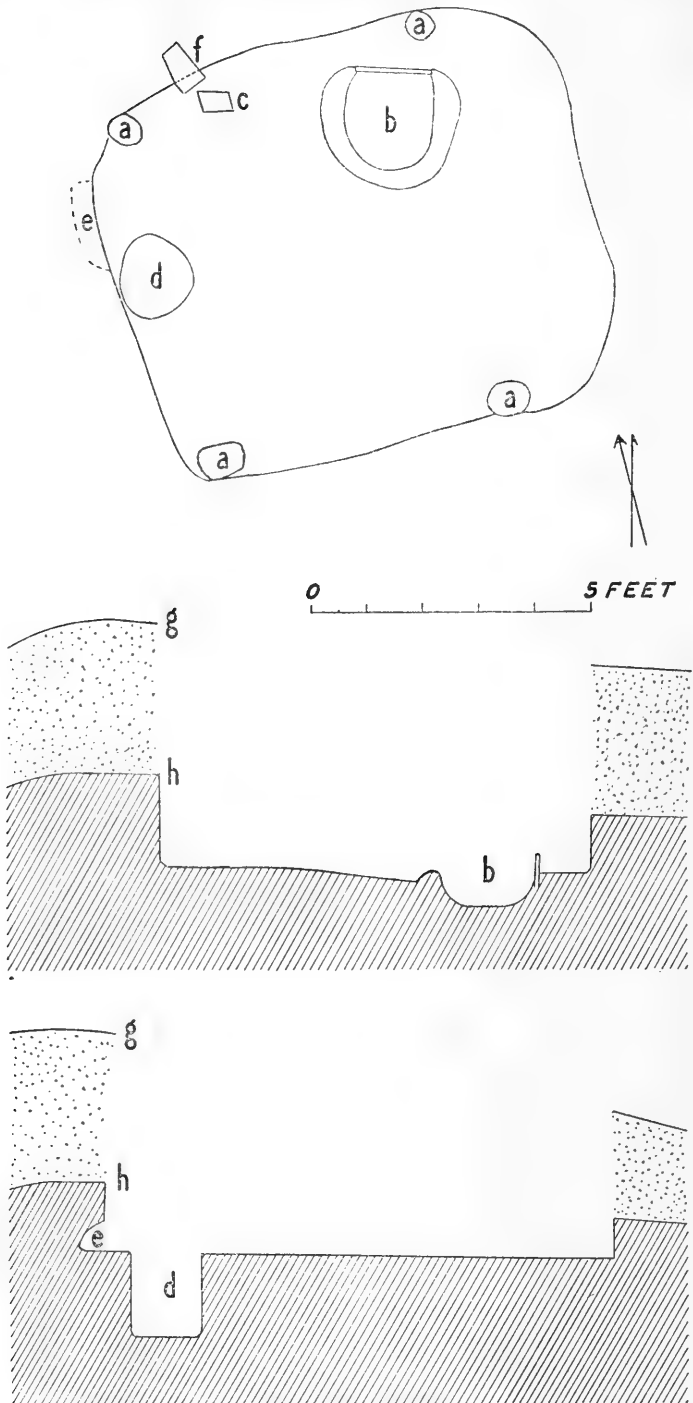
FIGURE 46.—Brush shelter. *a*, holes for roof supports; *b*, fire pit; *c*, stone step; *d*, storage pit in floor; *e*, subwall pocket; *f*, stone tread; *g*, present surface; *h*, old ground level.

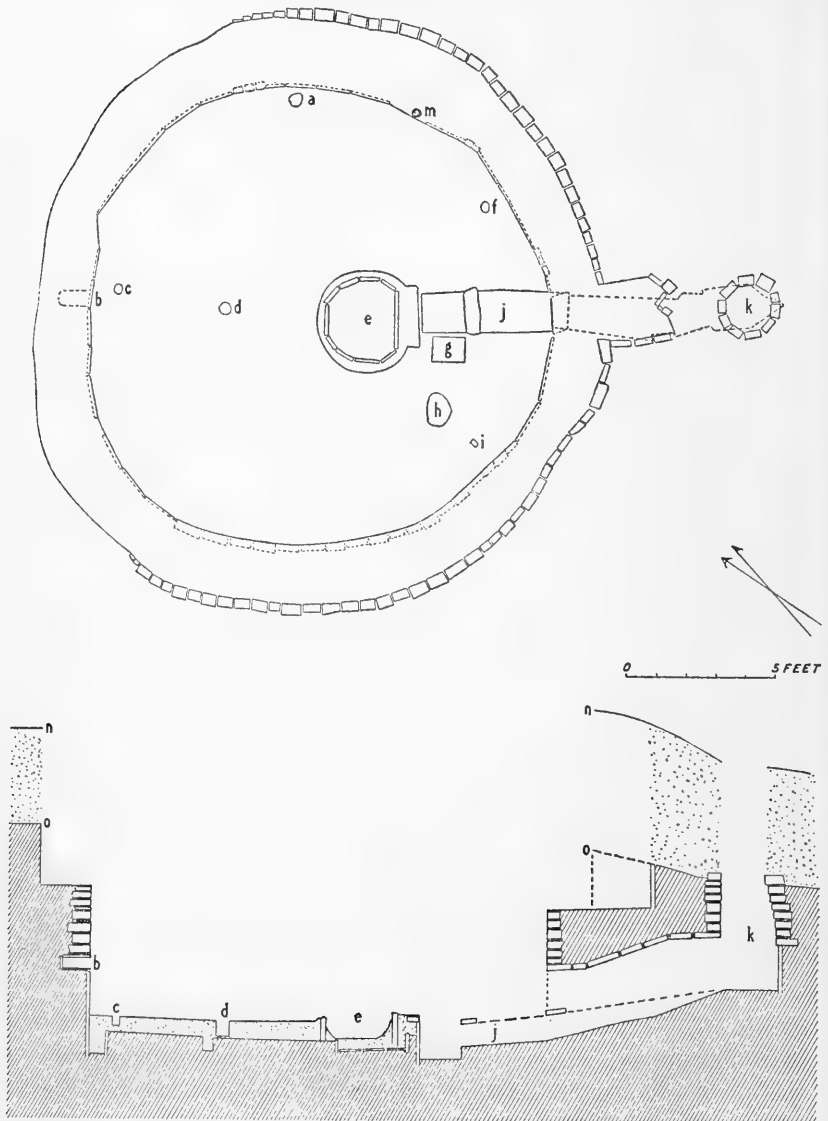
FIGURE 47.—Kiva B, upper floor level. *a*, storage hole in floor; *b*, Katsina niche; *c*, storage hole in floor; *d*, sipapu; *e*, fire pit; *f*, storage hole; *g*, ash pit; *h*, stone in floor; *i*, stone in floor; *j*, subfloor ventilator trench; *k*, ventilator shaft; *m*, post incorporated in bench; *n*, present ground level; *o*, original surface.

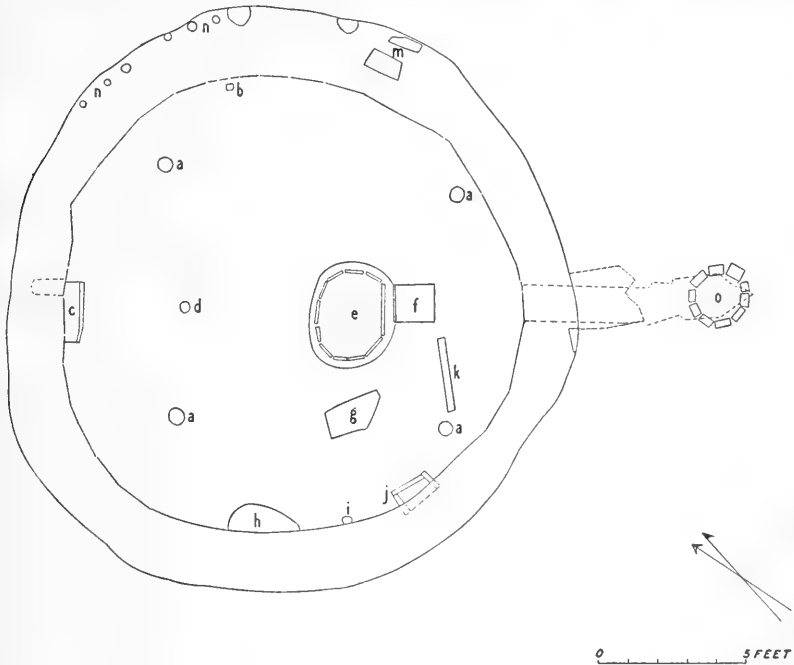
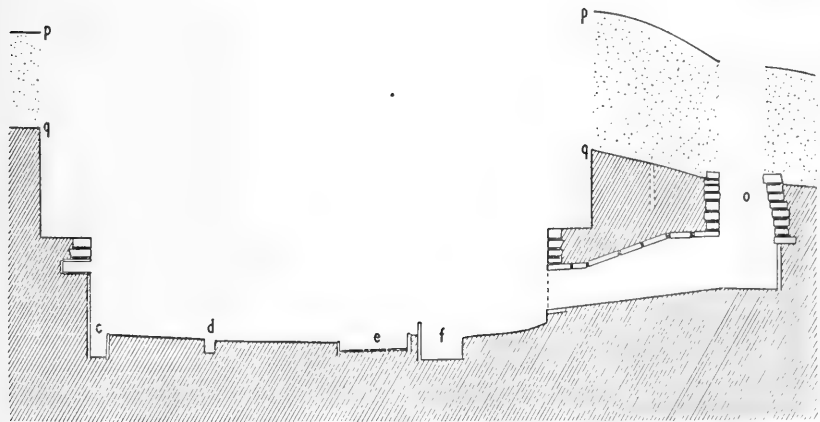
FIGURE 48.—Kiva B, original floor level. *a*, holes for main roof posts; *b*, stone in floor; *c*, storage box; *d*, sipapu; *e*, fire pit; *f*, ladder box; *g*, stone embedded in floor; *h*, storage pit; *i*, storage hole; *j*, subwall storage box; *k*, stone in floor; *m*, stones embedded on bench top; *n*, holes for slanting side poles; *o*, ventilator shaft; *p*, present ground level; *q*, original surface.

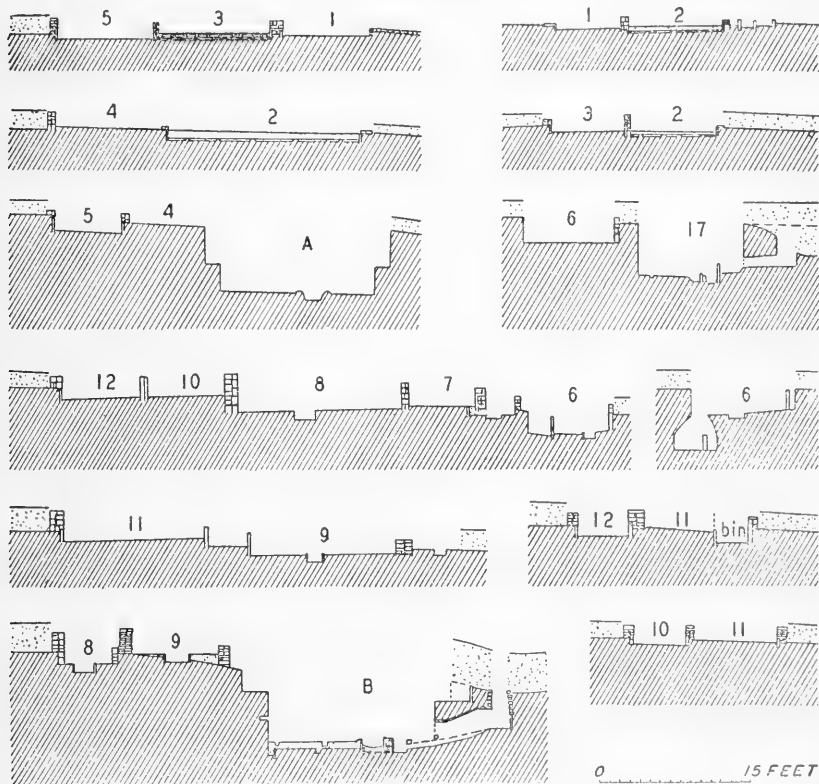
FIGURE 49.—Sections in first and second units.

flood waters found their way into the pit while the superstructure was still in place. Above these layers was a thick deposit of wind-blown sand containing some ash and sporadic pieces of charcoal. This stratum probably represents an appreciable interval, as it was rather evenly spread throughout the pit and of greater depth than average for this kind of material in the district. Above this was a thick stratum of coarse clay streaked with lines of decayed wood. The level unquestionably represents the stage when the roof col-

lapsed and fell into the partially filled pit. The clay was the melted-down plaster and roof material. On top of this layer were half a dozen thinner strata composed of water-washed sand and clay containing some small fragments of charcoal and occasional traces of ashes, and two thicker layers of sand, clay, and charcoal. These unquestionably were carried into the depression by an intermittent series of small floods sweeping down across the site. When the latter had been deposited the pit was filled to the top of the masonry wall at the back of the bench. Then several layers of clean sand and gravel were left there and these in turn were covered by wind-

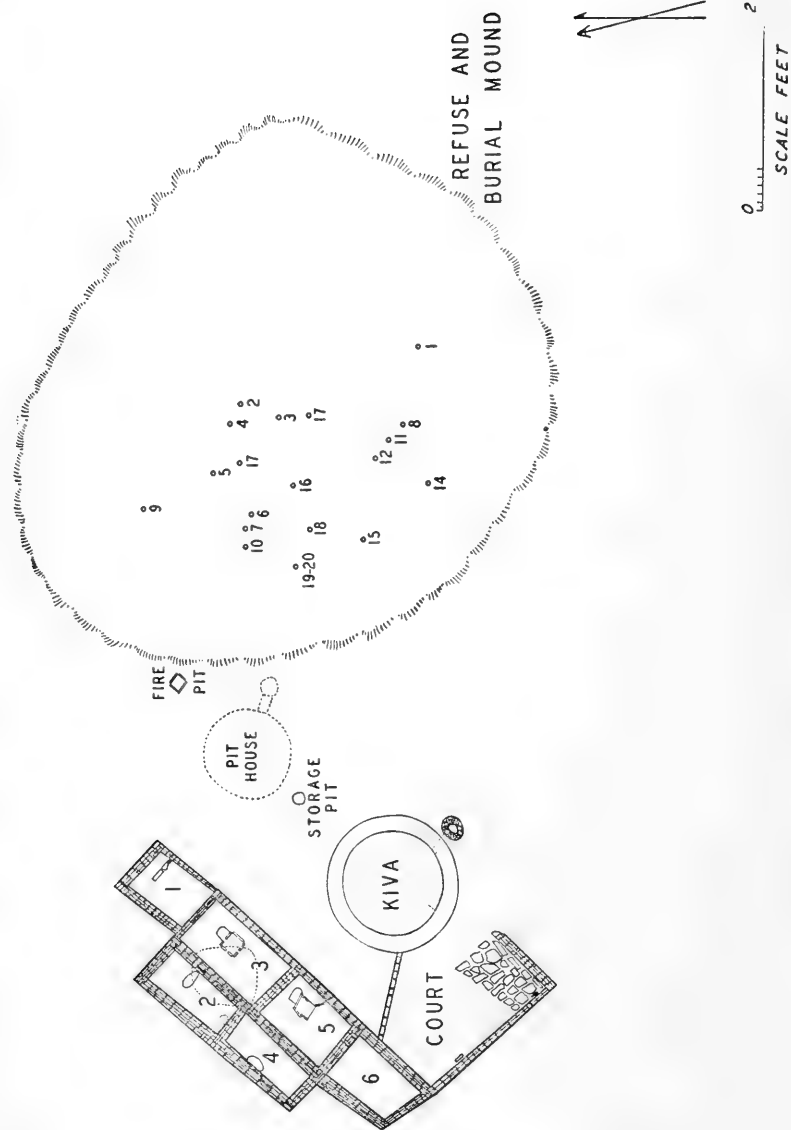
FIGURE 50.—Plan of unit No. 3. Dotted lines indicate location of pit structure 18. Numbered dots show positions of burials.

The surface structure was built on an approximation of the block plan with a double tier of rooms, 2 in one row and 4 in the other (fig. 50). The structure was not erected as a complete building on a preconceived ground plan, but, as in the case of the second unit, grew as the result of additions to an original nucleus. The first construction was that of rooms 2 and 4. This was followed by the erection of rooms 3 and 5, and subsequently by 1 and 6. There was nothing to show the relation between 1 and 6. Whether one or the other was added first or both represent a single stage of activity was not evident in the remains. The general status, however, indicated that there was no great interval of time represented by the various additions. It is quite possible that 3 and 5 were started soon after the completion of 2 and 4 and that 1 and 6 were not long in following. The construction work was much better in this building than in either the first or second units. The walls were of horizontally laid masonry. One course of large blocks served for the foundations. Above these the stones were smaller, more tabular in shape, and formed a solid, compact wall. Many of the blocks were shaped and dressed. There was a greater percentage of stone to mud mortar in this structure than in the preceding ones and more use of small

The court at the southeast corner of the dwelling (fig. 50) was enclosed by a low masonry wall that was erected at the same time as those forming room 6. Judging from the amount of fallen material and the remaining portions of the wall, the total height had never been more than approximately 3 feet (91.44 cm). Due to the slope of the original surface at this point, it was necessary for the builders to do some terracing. The southeastern third of the enclosure was built up with dirt and rocks and the upper surface paved with stone slabs. The wall at this end originally extended to the kiva and both it and the paving seem to have been carried across the kiva roof to the hatchway. This was indicated by the presence of wall material and large slabs well up in the deposits in the pit for that structure. A low wall, connecting room 6 and the kiva, also served to terrace that side of the court and hold back the earth placed there to level that part of the area. There was nothing to suggest that the wall had ever risen above the floor level along that side. The entire enclosed surface, including the paved section, was covered with hard-packed adobe flooring. There were no indications that fires had been lighted anywhere in the court. Not far from the southwest corner a stone slab

The outdoor fire pit (fig. 50) was a rectangular box lined with stone slabs. There were no traces of any shelter or arbor near it. It probably was like those scattered over the refuse mound for the second unit, merely a place where fires could be kindled when no shade or protection was needed. Some cooking was done there, however, because the ashes and charcoal that filled the pit had some splinters and fragments of charcoal and bone scattered through them.

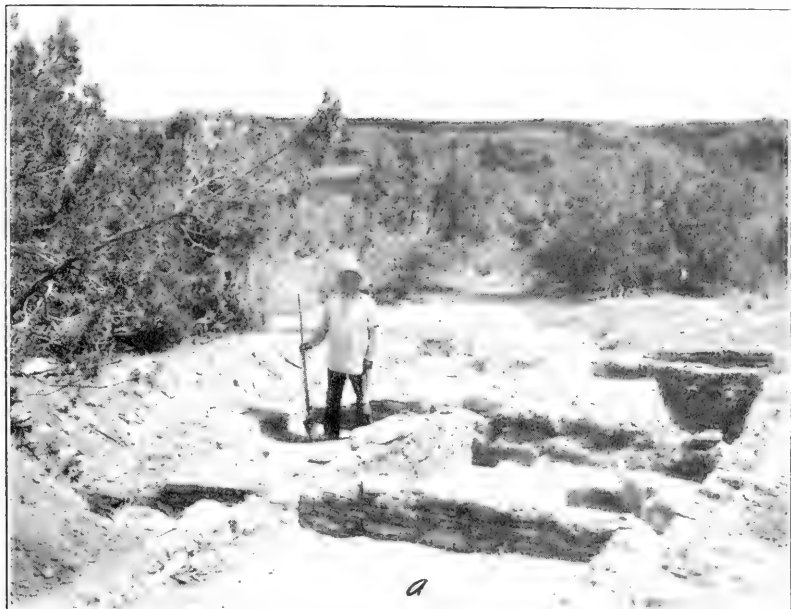
a. Surface structure in third unit

chinking stones. The walls stood only from 1 foot (30.48 cm) to 1 foot 6 inches (45.72 cm) in height at the time of excavation, but there was sufficient fallen material to show that they formerly were of single story height. The debris indicated that the masonry had been consistent throughout. The general appearance of the remaining walls was comparable to that of the late construction in the surface building of the second unit, room 9 particularly, although in this instance the work was better done and exhibited an improved technique (pl. 27, *a*).

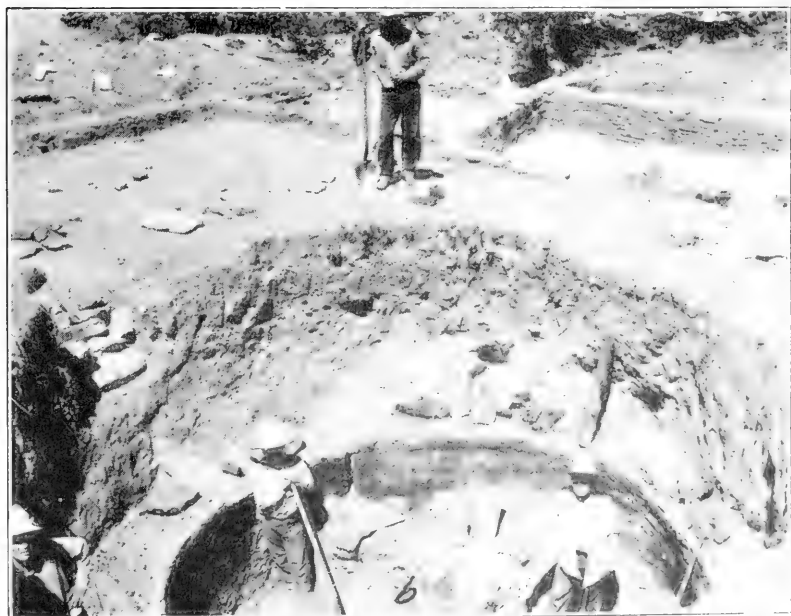
b. Clearing debris from kiva for third unit.

The kiva, located in the angle formed by the surface building and the court (pl. 27, *b*), more nearly approximated the circular form than any of the semisubterranean structures hitherto described. Both the back wall of the bench and the main wall of the chamber were more regular. The bench was partially dug and partially built up. When the pit for the main part of the chamber was dug, a narrow encircling shelf was left at the level for the bench top. Then when the walls of the pit were lined with stone the masonry was carried to that point and the width increased in proportion to the thickness of the wall. The stonework was very good; in fact it was the best wall

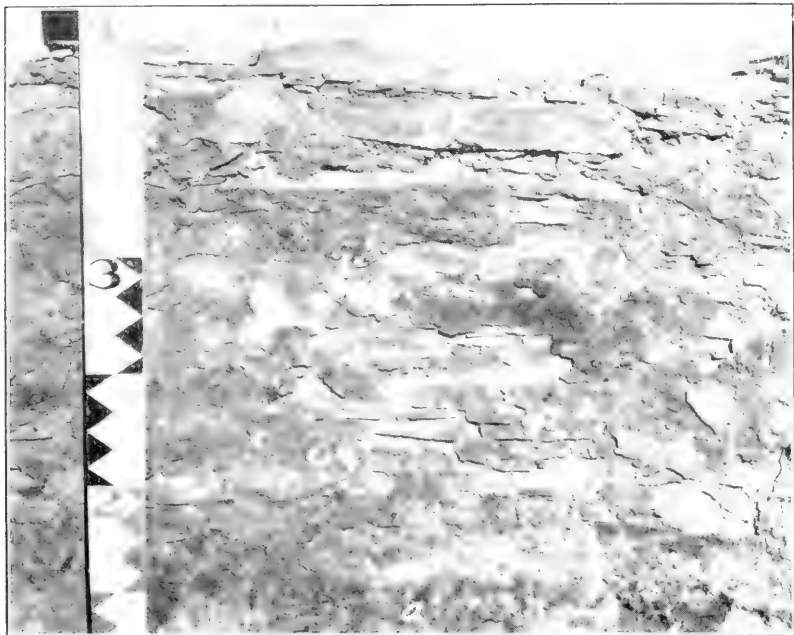
a. Wall construction in bench of third unit kiva.

construction found in the course of the excavations. Medium-sized tabular blocks were used for the main courses, except for a few larger stones that occurred near the top of the wall, and many small fragments were employed as chinking (pl. 28, *a*). A thick coating of adobe plaster gave a smooth-finished surface to the wall.

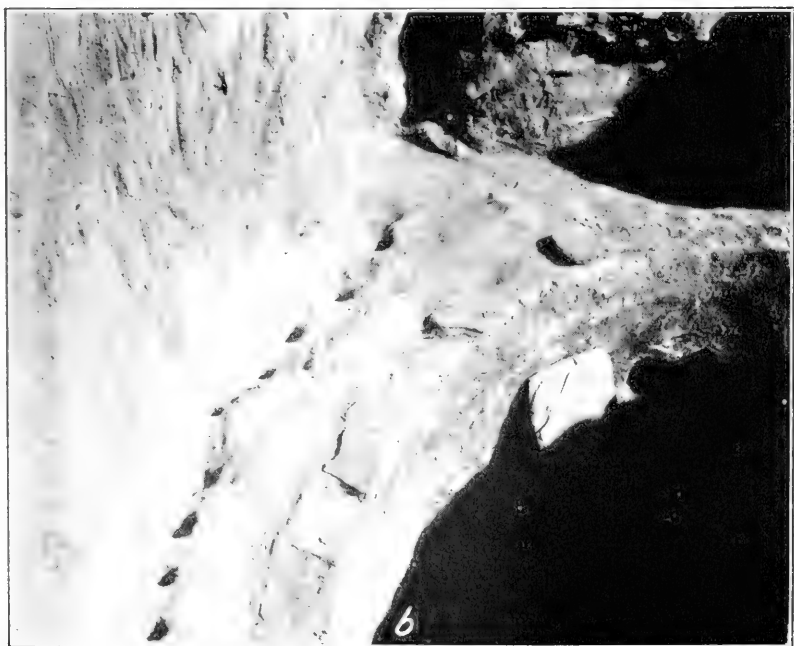
b. Holes for wainscoting poles at back of kiva bench.

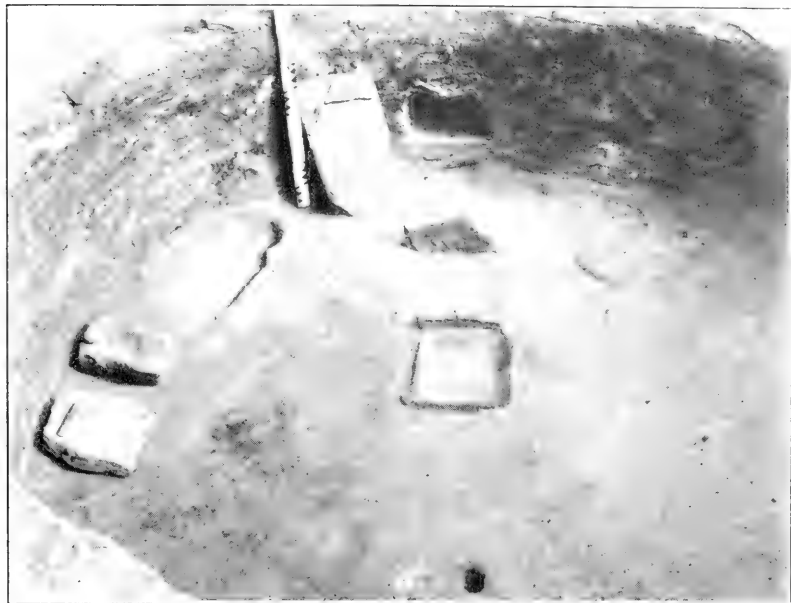
a. Floor in kiva for the third unit.

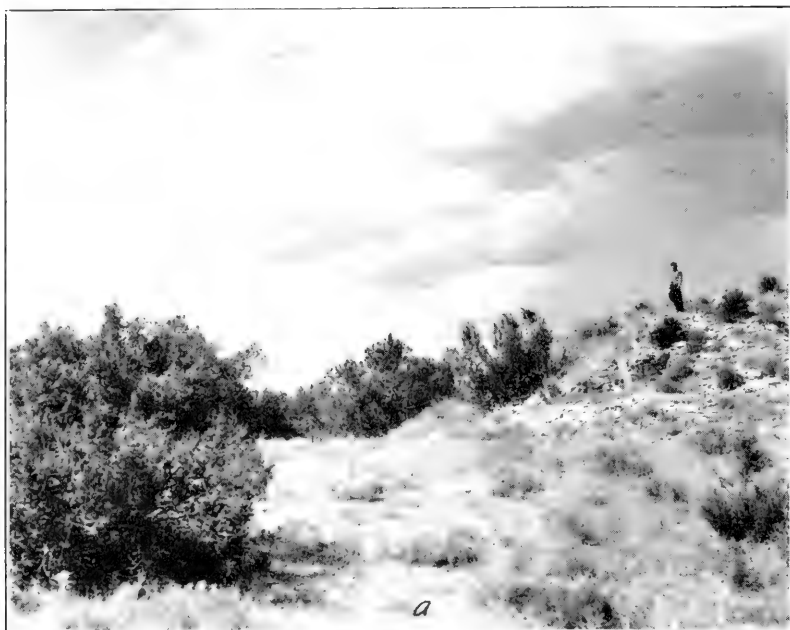
a. Portion of Great Pueblo ruins, corner of building below and to left of standing figure.

of debris was moved to locate the walls at several corners and at a few places along the outside walls, but beyond this no digging was done (pl. 30, *a*). By locating the ends of walls and such corners as were visible, a plan was drawn showing the general outlines of the structures and those features apparent on the surface (fig. 53). The larger of the two main buildings conformed to a rectangular-block plan. The smaller was made up of two units joining so as to form an obtuse angle and provide a court in which a large kiva or ceremonial chamber was located. Near one end of the smaller structure was a great kiva that was connected to it by a wall extending from the corner to the curved wall of the circular chamber. This wall served to accentuate, or perhaps better to complete, the court feature. Some distance from the two large mounds were the remains of two small rectangular structures. They stood in front of the main buildings and seem to have been either single-roomed houses or the lower parts of towers. This could not be determined without excavation. Their location and relation to the other remains is somewhat unusual. The ground plan of the group as a whole has a regularity and symmetry that suggests the builders were following some preconceived idea and not just erecting houses. The refuse mounds for the community were located to the east of the buildings. One of them had been cut by drainage water from the area surrounding the ruins and as a result was traversed by two sizable arroyos. These exposed the stratification and showed the depth of the accumulation (pl. 30, *b*).
